# Manhole Inspection Summary

Manhole # S29KK1003MH

**Location** Address: **OVERHILL RD**

Cross Street: **WICKFORD RD**

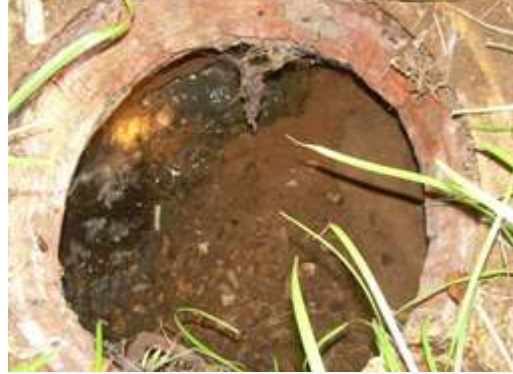
Top View

Corroded steps. Channel debris.

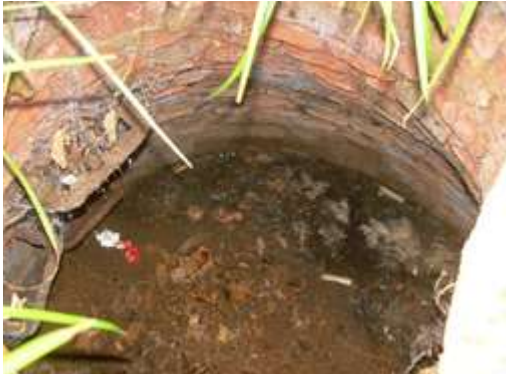
Defect

Corbel deterioration and infiltration.  
Barrel infiltration.

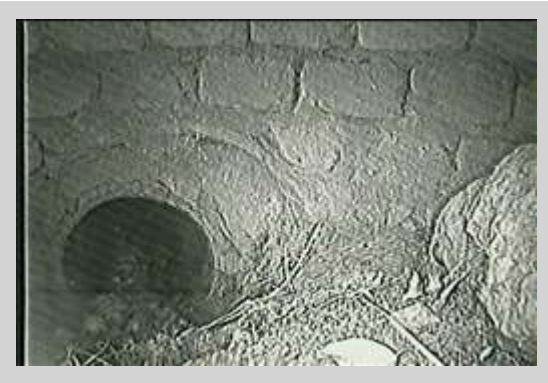
### 6 in. Circular Gravity Sewer Pipe Out @ 12 O'Clock

Barrel deterioration and infiltration.

Deposits: ☐ None ☐ **Mud** ☐ Sludge ☒ **Debris** ☐ Grease

Infiltration: **None** Pipe Seal Cond: **Cracked**

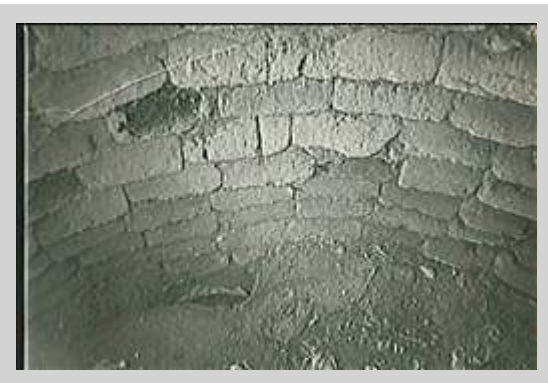
### 6 in. Circular Gravity Sewer Pipe In @ 4 O'Clock

Corbel and Barrel deterioration and infiltration.

Deposits: ☐ None ☒ **Mud** ☐ Sludge ☒ **Debris** ☐ Grease

Silt Depth: **6** (in.) Deposits Extent: **Heavy**

Infiltration: **Evidence** Pipe Seal Cond: **Unknown**

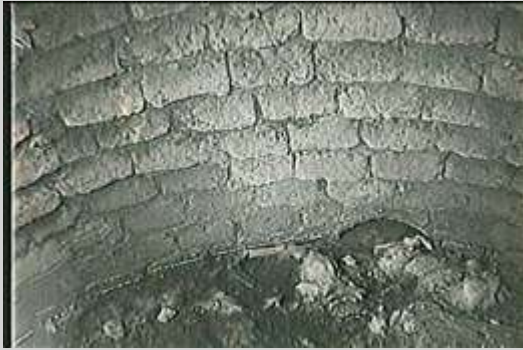
Pipe In @ 9 O'Clock

Deposits: ☐ None ☒ **Mud** ☐ Sludge ☒ **Debris** ☐ Grease

Deposits Extent: **Heavy**

Pipe Seal Cond: **Cracked**
